## Management of Communitated Cervical Root Fracture using Biodentine : A Case Report

H C Baranwal, Amrita Kumari, Neeraj Kumar, Management of Communitated Cervica Root Faecture using Biodentine: A Case Report. Indian J Dent Educ. 2020;13(2):79-82.

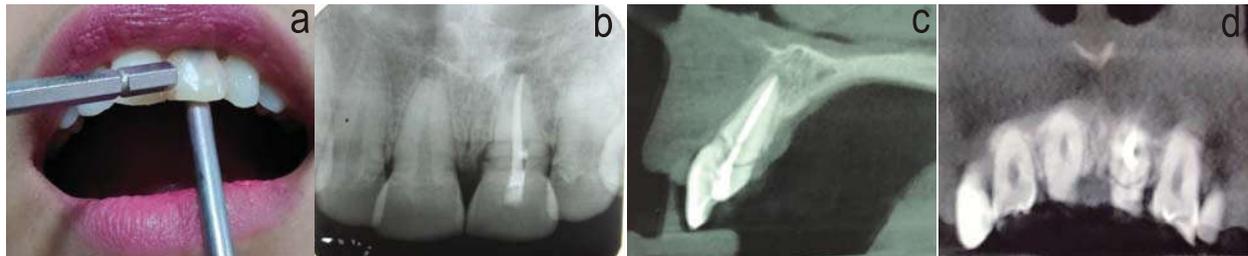
A 23 years old female patient presented with slight pain, mobility and discolouration of upper front teeth. She gave history of trauma and then dental treatment by some local private practitioner 4 months back. She advised extraction of that tooth because of no resolution in condition, however patient was not willing for extraction and thus reported to our department of conservative dentistry and endodontics, BHU, Varanasi for further consultation. Clinical examination revealed mobility of upper left central incisor buccolingually. There was no tender on percussion. There was composite material seen in mesial and distal surface of #21 with adjacent tooth as a splint. On Radiographic examination, IOPA showed Obturated #21 (FDI) with communited cervical root fracture. CBCT examination confirmed the

presence of multiple small fractures at the cervical third of the root and extent of the fracture line.

Fig. 1: (a) Pre-operative photograph checking mobility, (b) Pre-operative IOPA, (c) CBCT showing sagittal view, (d) CBCT showing axial view.

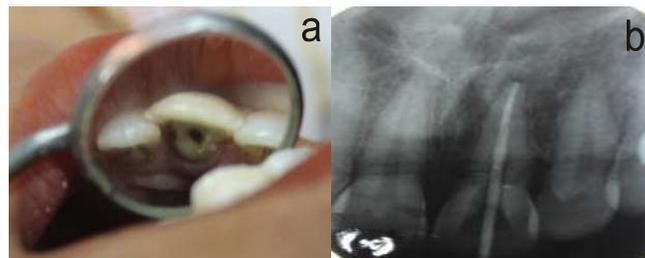
Fig. 2: (a) Biodentine in post space, (b) Fiber post in place

Considering all these conditions, sealing the fracture lines with biodentine and reattachment of the mobile fragment with fiber post was planned. Post space was prepared after stabilizing the crown with thumb and index finger, leaving apical 5 mm of GP. Canal was checked for fiber post fit and size #3 fiberpost was selected for reattachment procedure. BIODENTINE capsule was mixed in amalgamator for 30 sec at a speed of 4000-4200 rpm. Freshly mixed biodentine was introduced in canal to seal the fracture lines and cover dentine layer.

After preparing post space, biodentine is allowed to flow within the fracture site in the circumference of canal and then fiber post is placed in position. After proper itching and bonding procedure, the tooth was coronally sealed with dual cure resin cement. Once the tooth was reattached, patient was kept for follow up to evaluate any signs of further discoloration or mobility. Once the patient was aymptomatic the tooth was prepared for crown coverage. Six months follow up shows no mobility and pain.

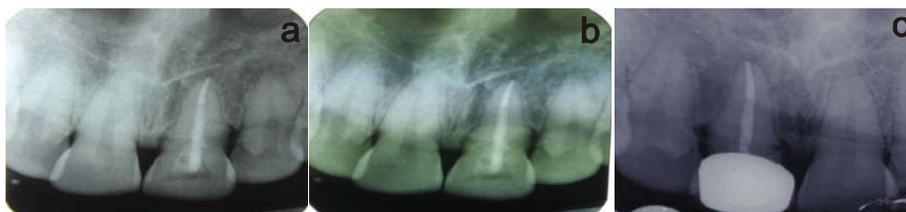
Fig. 3:(a) Post-operative IOPA, (b) Follow-up IOPA after 3 months, (c) Follow-up IOPA after crown placement

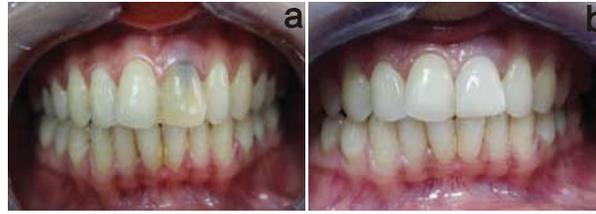
Fig. 4:(a) Pre-operative photograph, (b) Post-operative photographafter crown cementation.
